Doc.No. 5207-005000A Date: 200617 Approved by: PL

Change No. 19909

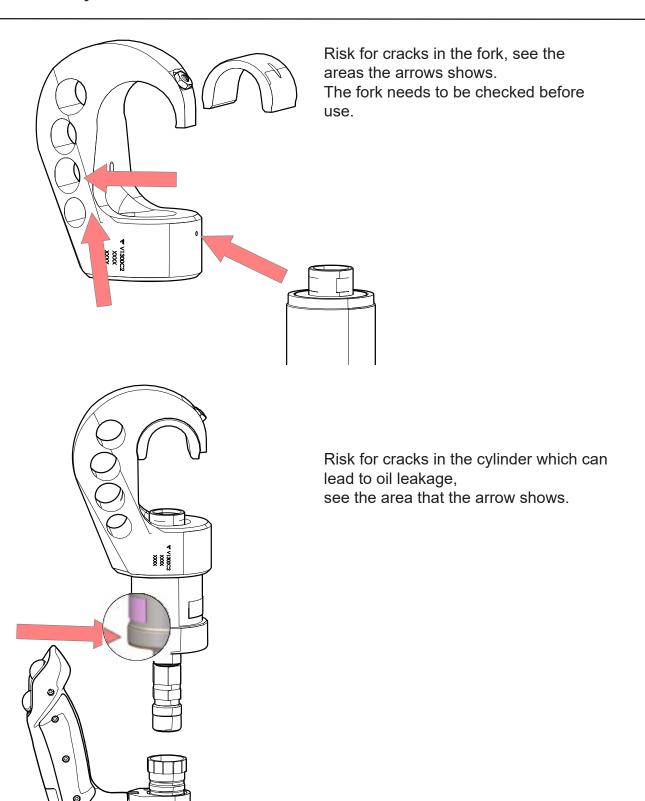
Risk for oil leakage in the quick coupling, see the area the arrow shows. It's is very important that the Ergo pipe is not loosen and it has it's original position to prevent sudden oil leakage.
